**SPECTRO INC.**  
Industrial Tribology Systems

**Lasernet Fines - C**

Customer/Site	Hrs/mile since overhaul	536	Operator	ANDERSONDP	
Machine	610200008	Hrs/mile since oil Chg	25	Sample Date	03/28/2001
Equip Name	Samp#	Fluid Type	10W30	Analysis Date	07/03/2001 21:54
Unit (Port)	1	Notes		Sample Seq #	1

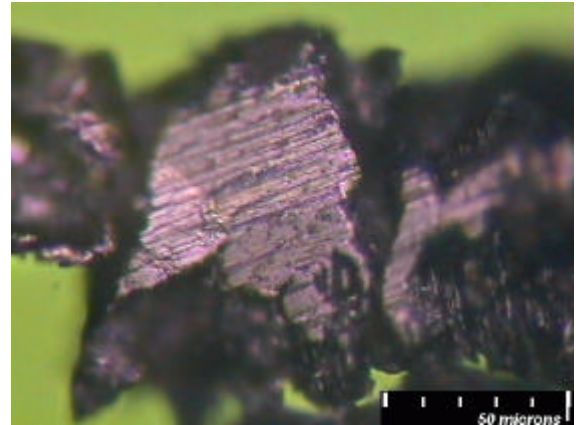
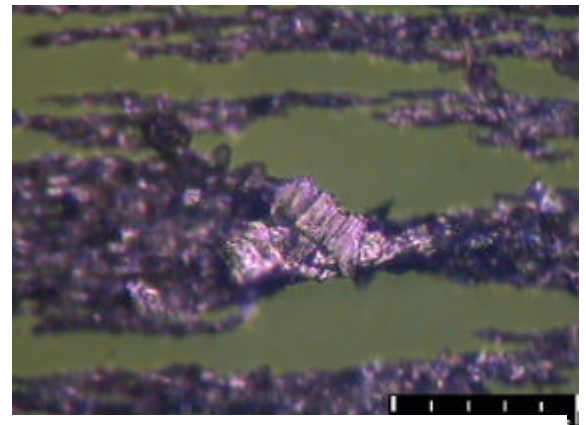
Customer/Site: \_\_\_\_\_ Notes: \_\_\_\_\_ Fluid Type: 10W30  
 Machine: 010210000 Sample: \_\_\_\_\_ Operating hrs/mile: \$ Sample: 02/21/2001 Seq# 0  
 Equip Name: \_\_\_\_\_ Hrs/mile since overhaul: \$ Operator: ANDERSONHP  
 Unit (Port): 1 Hrs/mile since oil Chg: \$ Analysis: 07/06/2001 02:39

Hydraulic	Wear Summary	Cutting Wear	Sliding Wear	Fatigue Wear	NonMetallic Wear
-----------	--------------	--------------	--------------	--------------	------------------

Total Part/ml: 57277.9 Vol(ml): 0.206  
 Avg Diameter: 1.7 # Frames: 1,055  
 Std Diameter: 3.5  
 Max Diameter: 62.0

Num/ml	Mean (micron)	Std (micron)	Max size (microns)
Cutting:	23.6	34.1	9.0	49.7
Severe Sliding:	87.7	30.5	11.9	62.0
Fatigue:	128.2	23.5	3.7	37.8
NonMetallic:	13.5	37.1	6.2	43.0

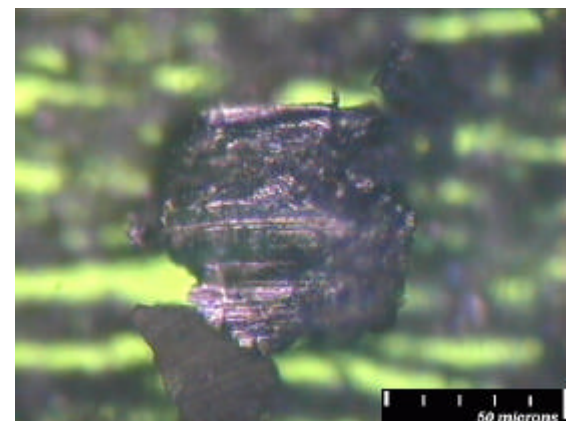
**Lasernet Fines - C**

Customer Site: \_\_\_\_\_ Notes: \_\_\_\_\_ Fluid Type: 10W30  
 Machine: B1020000 Sample: \_\_\_\_\_ Operating Hrs/mile: 264 Sample: 03/09/2001 Seg# 0  
 Equip Name: \_\_\_\_\_ Hrs/mile since overhaul: 264 Operator: ANDERSONDP  
 Unit (Port): 1 Hrs/mile since oil Chg: 11 Analysis: 07/09/2001 21:47

Hydraulic	Wear Summary	Cutting Wear	Sliding Wear	Fatigue Wear	NonMetallic Wear
Total Part/ml: 1070.0	Vol(ml): 0.65				
Avg Diameter: 3.2	# Frames: 4,066				
Std Diameter: 6.4					
Max Diameter: 149.9					
	Num/ml	Mean (micron)	Std (micron)	Max size (microns)	
Cutting:	9.2	27.7	3.7	33.1	
Severe Sliding:	7.7	20.9	5.6	37.0	
Fatigue:	24.6	38.4	30.4	149.9	
NonMetallic:	1.5	20.9	0.0	20.9

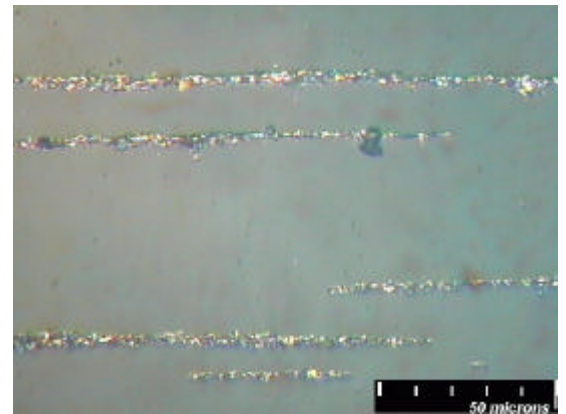
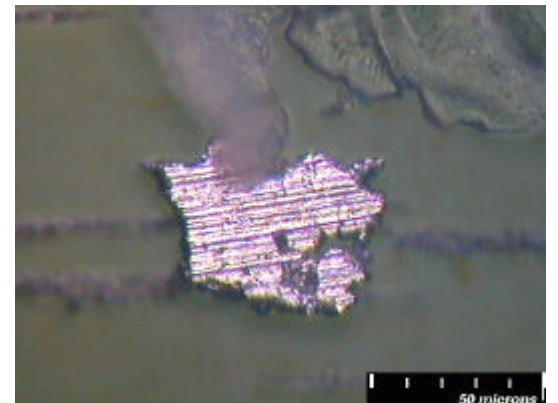
Customer Site: \_\_\_\_\_ Notes: \_\_\_\_\_ Fluid Type: 10W38  
 Machine: B10200000 Sample: \_\_\_\_\_ Operating Hrs/mile: 367 Sample: 03/16/2001 Seg# 0  
 Equip Name: \_\_\_\_\_ Hrs/mile since overhaul: 367 Operator: ANDERSONDP  
 Unit (Port): 1 Hrs/mile since oil Chg: 20 Analysis: 07/09/2001 21:54

Hydraulic	Wear Summary	Cutting Wear	Sliding Wear	Fatigue Wear	NonMetallic Wear
Total Part/ml: 745.4	Vol(ml): 0.065				
Avg Diameter: 2.5	# Frames: 4,065				
Std Diameter: 5.5					
Max Diameter: 96.2					
	Num/ml	Mean (micron)	Std (micron)	Max size (microns)	
Cutting:	3.1	25.4	1.3	26.7	
Severe Sliding:	1.5	96.2	0.0	96.2	
Fatigue:	7.7	27.8	7.3	42.2	
NonMetallic:	3.1	23.1	3.0	26.2

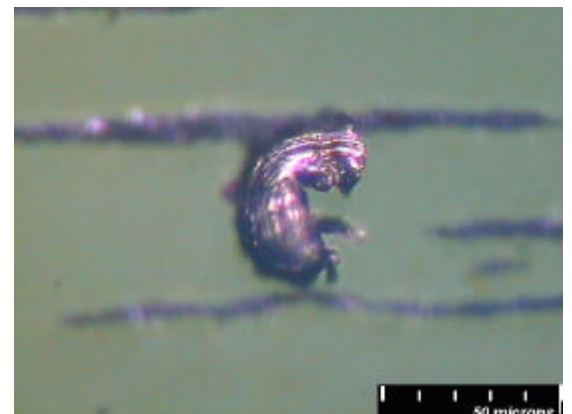
**Lasernet Fines - C**

Customer/Site: \_\_\_\_\_ Notes: \_\_\_\_\_ Fluid Type: 10W30  
 Machine: 61020003 Samp#: \_\_\_\_\_ Operating hrs/mile: 411 Sample: 03/20/2001 Seq#: 1  
 Equip Name: \_\_\_\_\_ Hrs/mile since overhaul: 411 Operator: ANDERSONDP  
 Unit (Port): 1 Hrs/mile since oil Chg: 33 Analysis: 07/09/2001 22:15

Total Part/ml: 11367.2 Vol(ml): 0.644  
 Avg Diameter: 2.2 # Frames: 4,028  
 Std Diameter: 4.0  
 Max Diameter: 60.2

Num/ml	Mean (micron)	Std (micron)	Max size (microns)
Cutting:	3.1	26.0	1.3	29.3
Severe Sliding:	32.6	27.5	8.3	60.2
Fatigue:	55.9	24.5	5.8	54.0
NonMetallic:	12.4	28.0	4.3	37.7

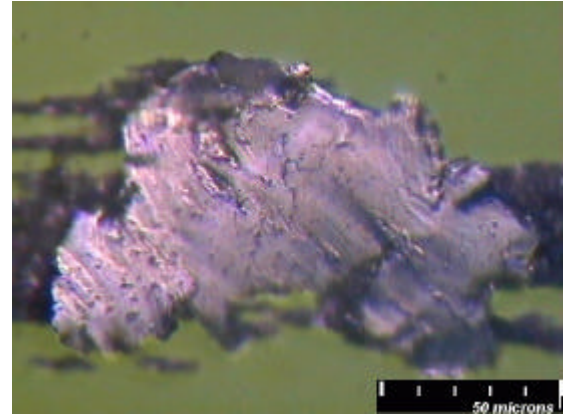
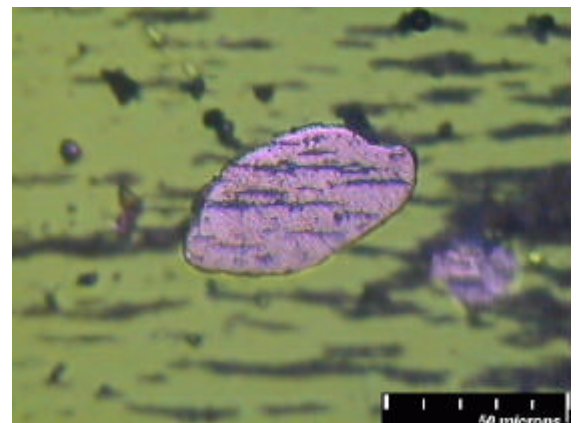
Customer Site:	Notes:	Fluid Type:	10W30
Machine: 01020000	Sample#:	Operating Hr/mile:	534
Equip Name:	Hrs. mile since overhaul:	534	Operator: ANDERSONDP
Unit (Port): 1	Hrs/mile since oil Chg:	23	Analysis: 07/03/2001 22:07

Total Part/ml:	24492.6	Vol(ml):	0.3
Avg Diameter:	3.5	# Frames:	1,876
Std Diameter:	4.6		
Max Diameter:	88.1

Num/ml	Mean (micron)	Std (micron)	Max size (microns)
Cutting:	3.3	20.1	0.0	20.1
Severe Sliding:	43.4	34.1	18.9	88.1
Fatigue:	133.4	27.4	12.3	84.8
NonMetallic:	13.3	24.9	6.1	33.5
