FieldLab 58C

A mobile oil analysis tool to detect abnormal wear and lubrication issues to avoid unplanned repairs

Reliability Consultant | Spectro Scientific

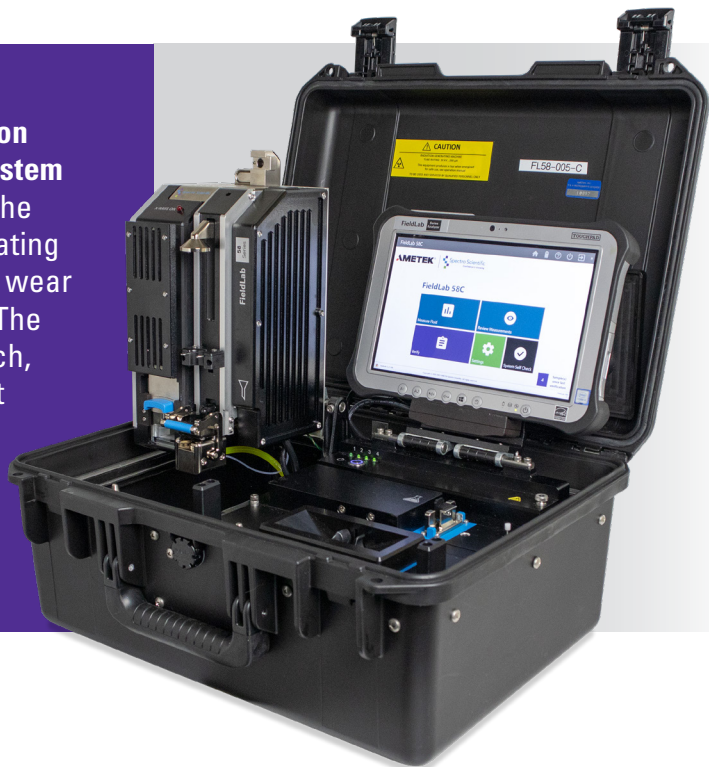
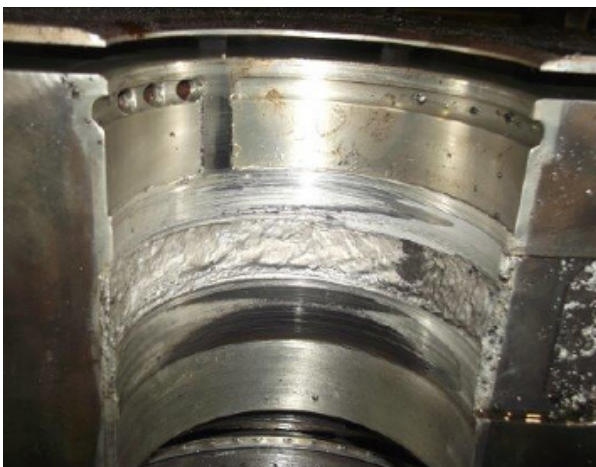
Figure 1: FieldLab 58C Portable Fluid Analysis System

The new FieldLab 58C is the latest generation of a very innovative portable oil analysis system first introduced in 2012. Unique features of the system include the ability to measure lubricating fluid viscosity, fluid chemistry and abnormal wear debris in a few minutes, and report results. The wear debris approach is a patented approach, developed for addressing the need to detect abnormal (>4 micron) wear particles and determine their elemental makeup.

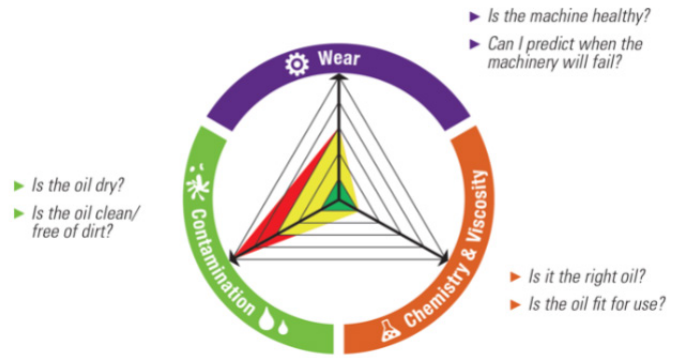
Figure 2: Trivector™ oil analysis: A powerful way to summarize data from all 3 facets of oil analysis by graphically illustrating direction and severity of faults, enabling quick decision making

Oil analysis does not refer to one or two tests, rather a suite of tests chosen to ensure three aspects are addressed - as shown in Figure 2.

The Trivector™ is a very effective radar plot covering all aspects, thus enabling any equipment maintainer to quickly visualize the equipment health and immediately form an action plan to address abnormalities.

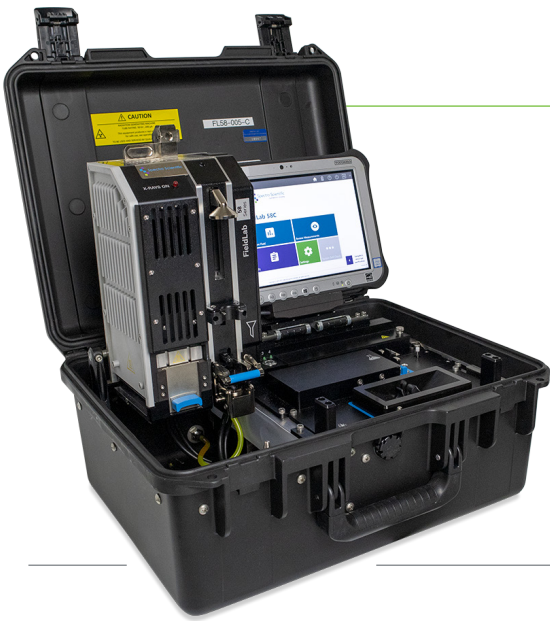
Figures 4a and 4b shows the filtergram particle quantifier (FPQ) having an active area portion of the 4-micron filter membrane where wear debris accumulates. The FPQ specimen is labeled, XRF elemental analysis is performed, and the specimen is retained for visual and microscopic examination.

The Fieldlab 58C FPQ serves three purposes: pore blockage particle counting, x-ray fluorescence wear debris analysis, and specimen for viewing and further analysis as needed. Combined with the chemistry and viscosity results, the Fieldlab 58C provides a very detailed picture of machine components, system contamination, and lubricant condition. This rich information, with built-in diagnostics providing real actionable findings, empowers onsite personnel to begin planning for repairs or design change.

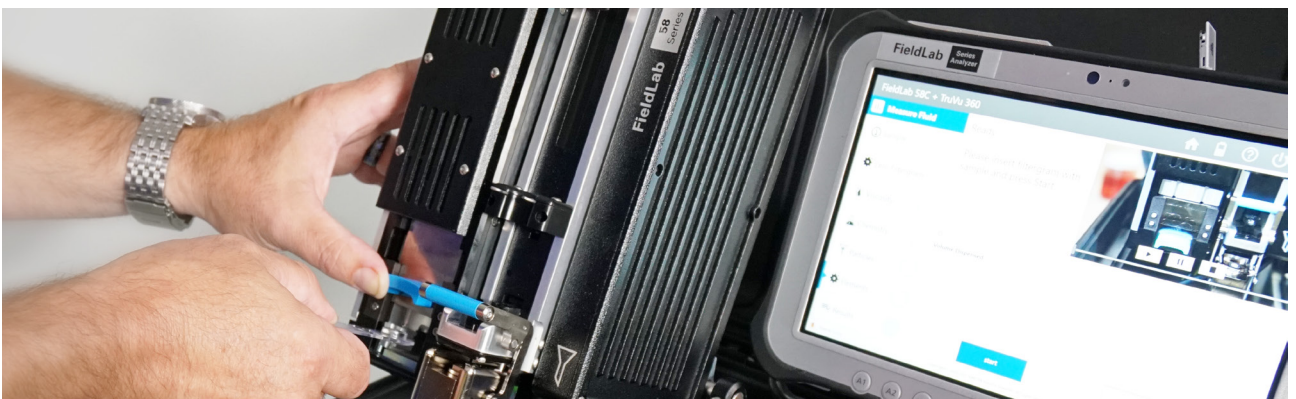
Figure 4b: Inserting FPQ Filtergram for XRF x-ray fluorescence.

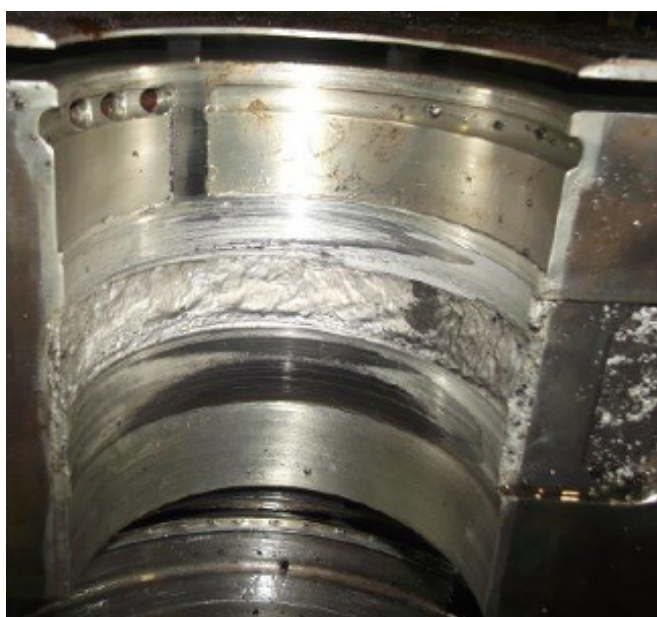
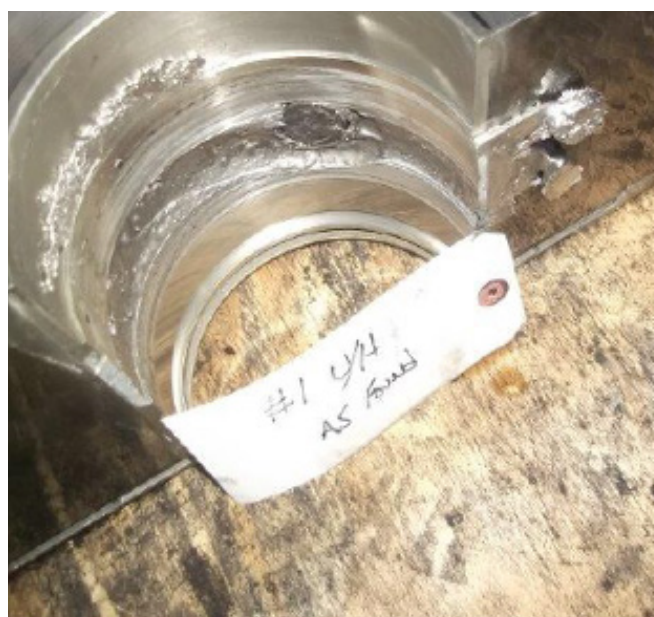
As found #1 bearing

Figure 6: Wiped #1 bearing.

The first 20 MW turbine generator experienced failure of radial, journal, and thrust bearings. Service outage for repair required 55 days, however costs were not reported. Figure 6 shows the failed #1 bearing, Figure 7 shows the wiped active and inactive thrust bearings, and Figure 8 shows the wiped #2 bearing and journal. Steam turbine generator radial bearing was wiped, active and inactive thrust bearings were wiped, and journal was severely damaged - all due to severe sliding wear. Situations of erratic control and rotor dynamics were likely causes and symptoms of multiple wiped bearings.

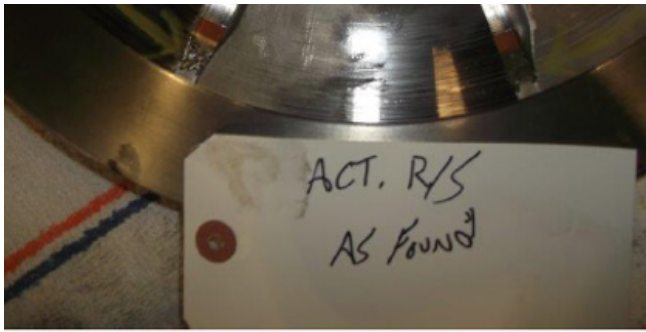
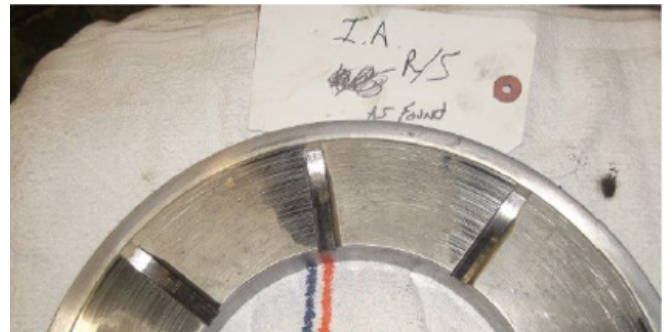
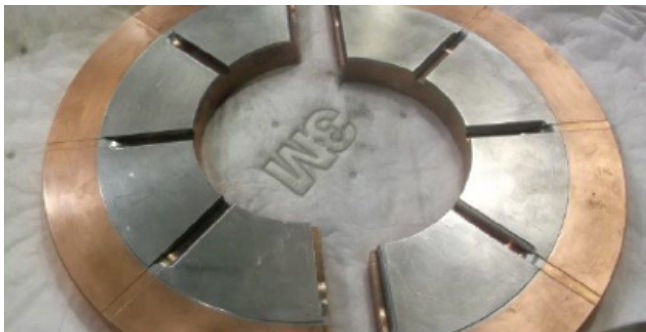
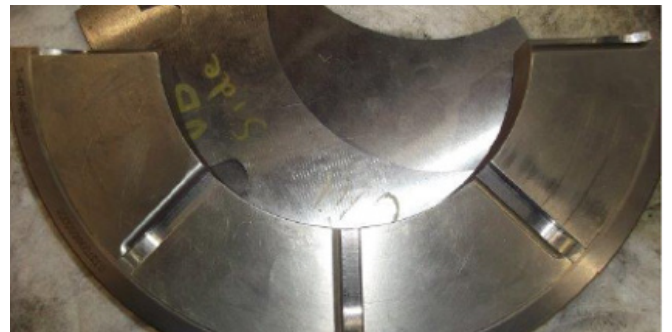
Figure 7: Wiped thrust bearing.

Active thrust (AF)

Inactive thrust (AF)

New active thrust

New inactive thrust

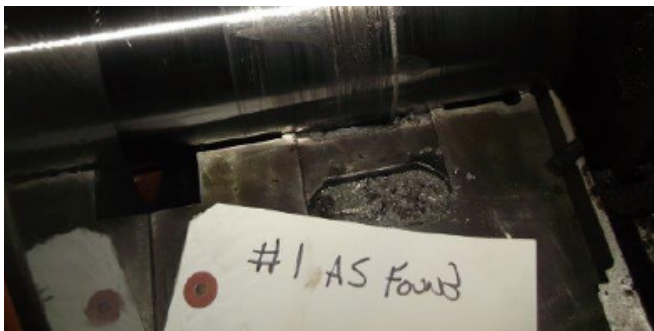
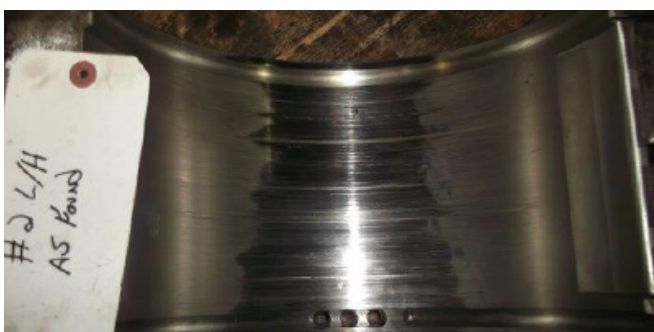
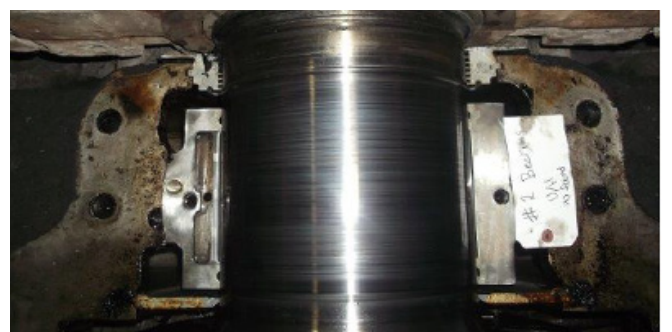
Figure 8: Wiped #2 bearing journal.

#1 journal (as found)

#1 journal (as left)

#2 bearing & journal (as found)

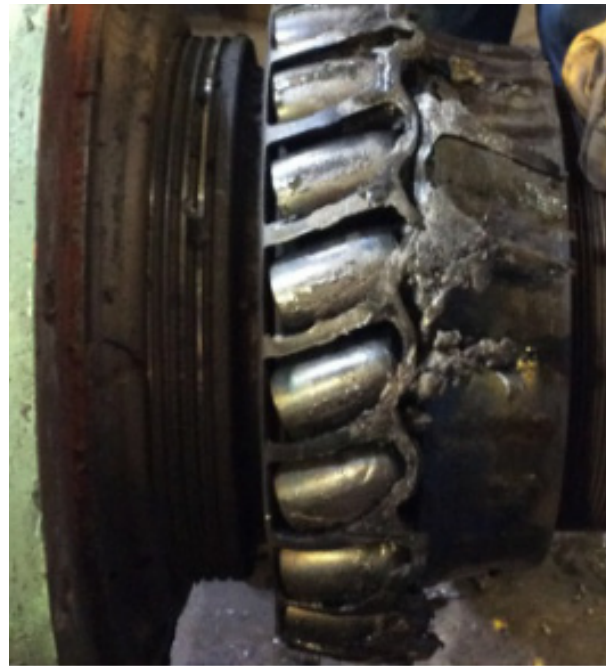
Figure 9: Queen roll bearing cage failed due to lack of lubrication

The costs due to failed queen roll bearing shown in Figure 8 were \$30,000 for repair, production loss \$324,000 and total \$354,000. Figure 9 image shows catastrophic wear debris was generated during failure sequence from copper alloy cage and iron alloy bearing components. The roller bearing cage failed due to inadequate lubrication. Vibration data was taken 3 days prior to the failure. Inspection of the bearing revealed that the cage had failed with severe sliding wear.
